"Paleoseismological
Investigations of Xaiyabouri
area, central Lao PDR"

Punya Charusiri, Santi Pailoplee
and Chinda Sutivanich

Earthquake and Tectonic Geology
Research Unit (EATGRU), Chulalongkorn
University

Myanmar Earthquake Committee, Yangon, May 11, 2013

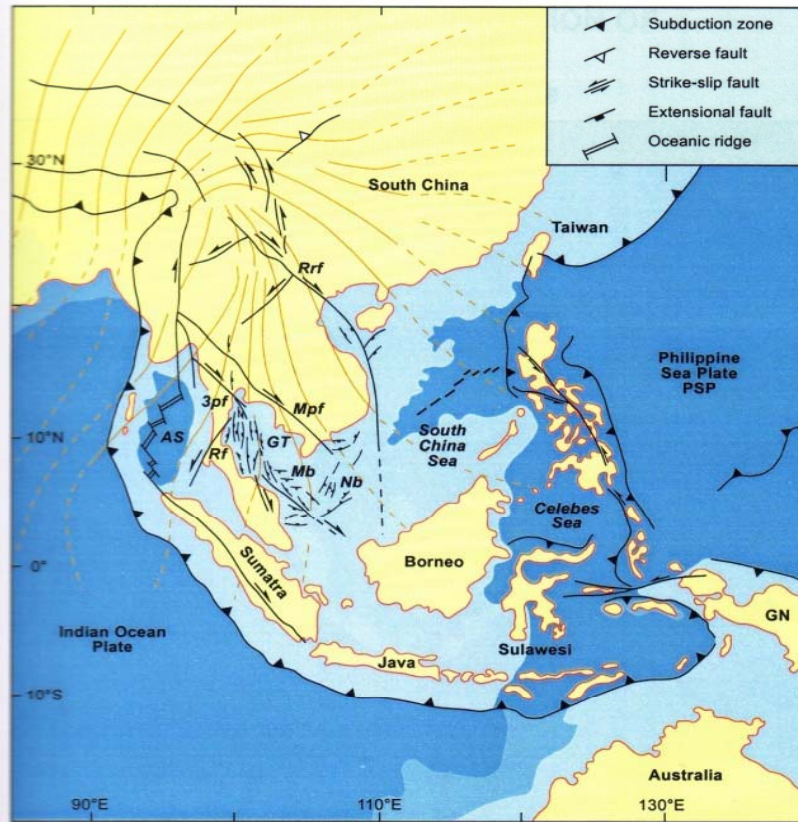
Present Day Tectonics of the Sunda Shelf

- Subduction zone
- Reverse fault
- Strike-slip fault
- Extensional fault
- Oceanic ridge

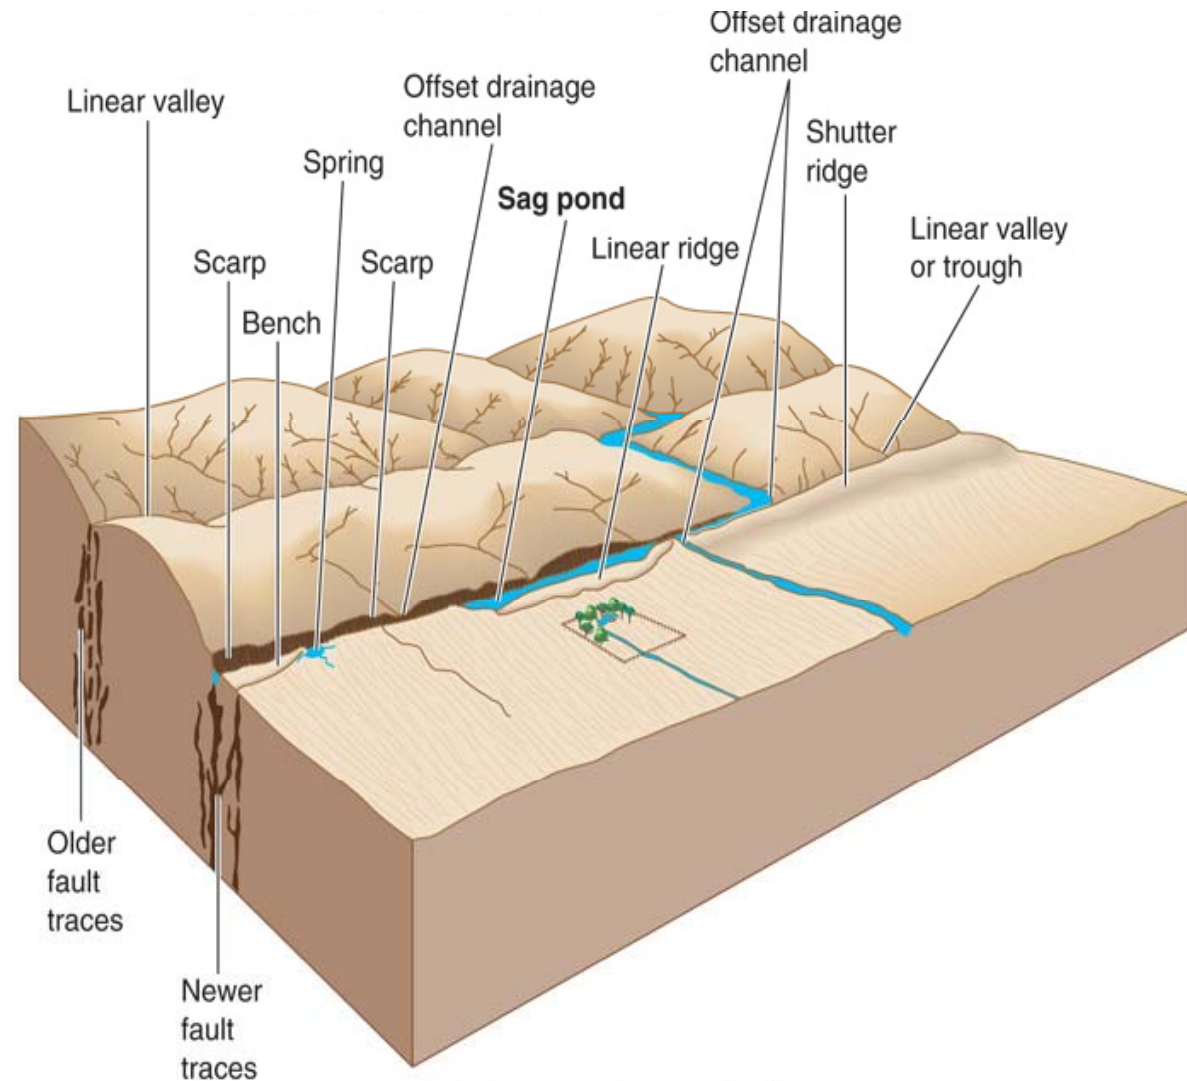
Characteristics of morpho-tectonic landforms associated with active faulting (McCalpin, 1996).

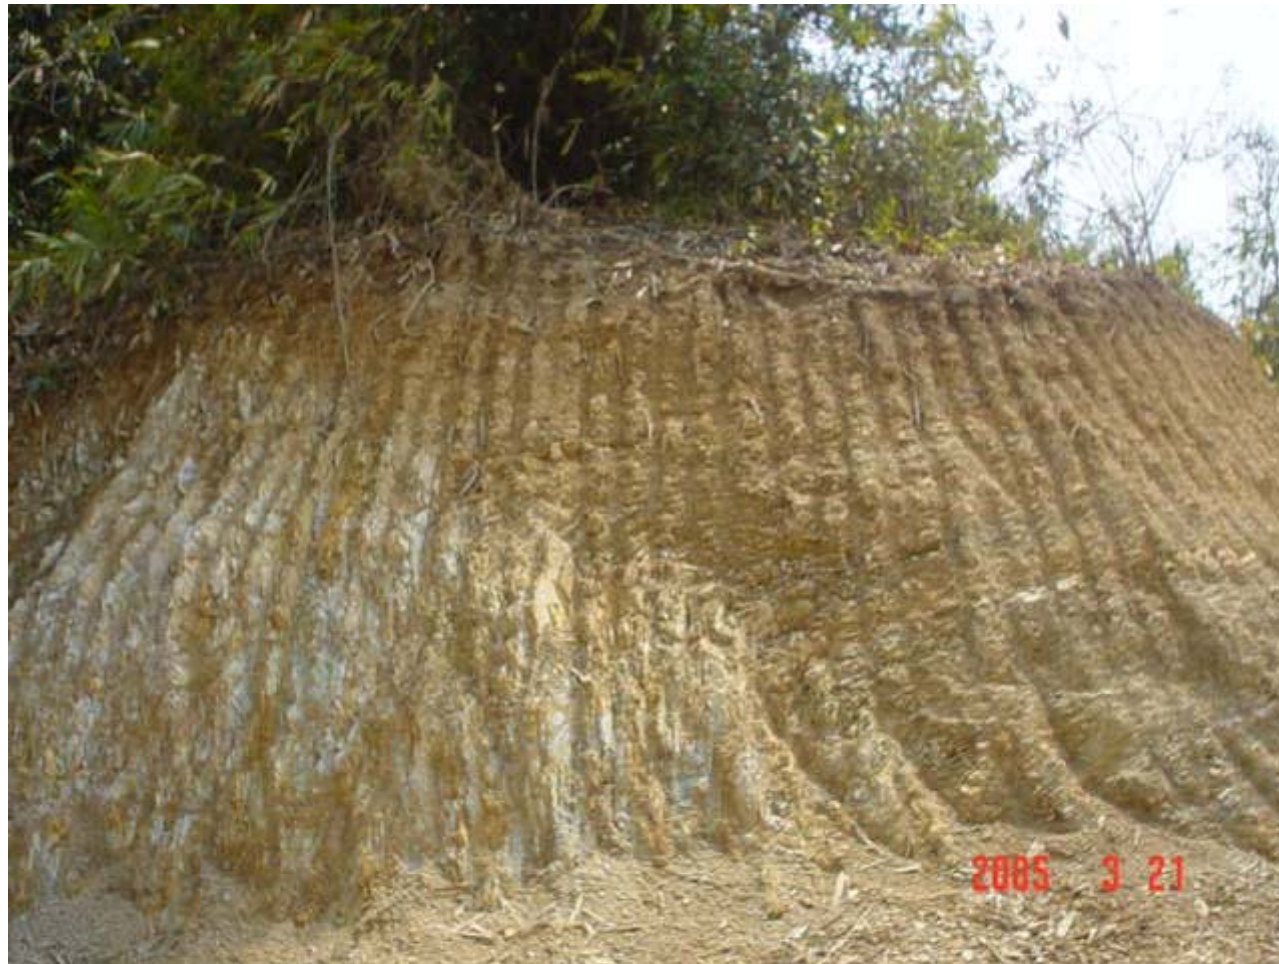
Outcrops near the fault zone

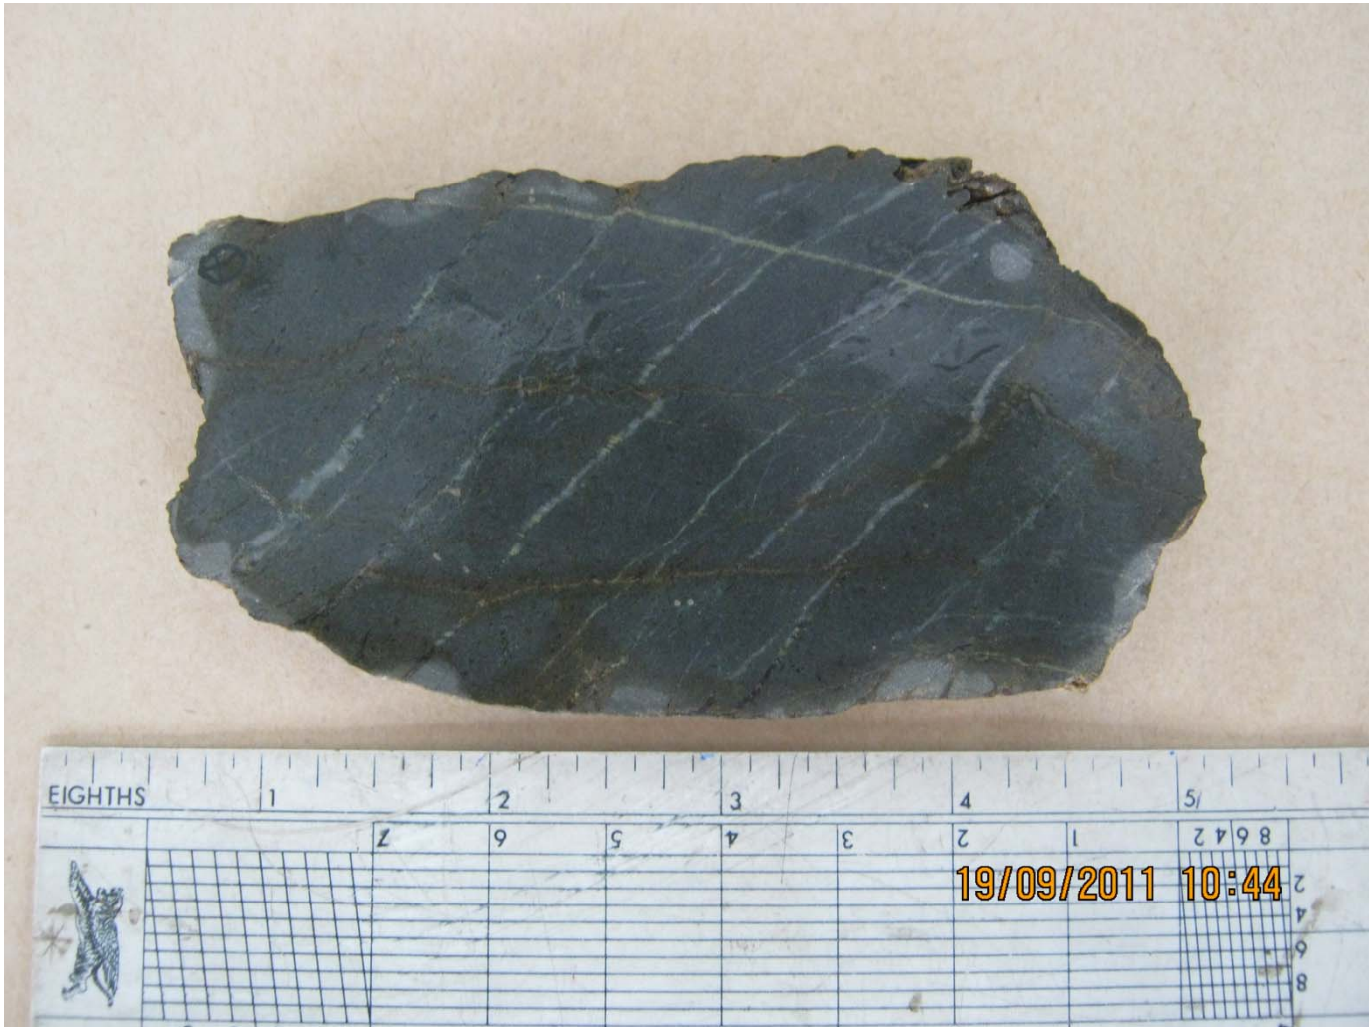
Offset chert pebble at the
barge site

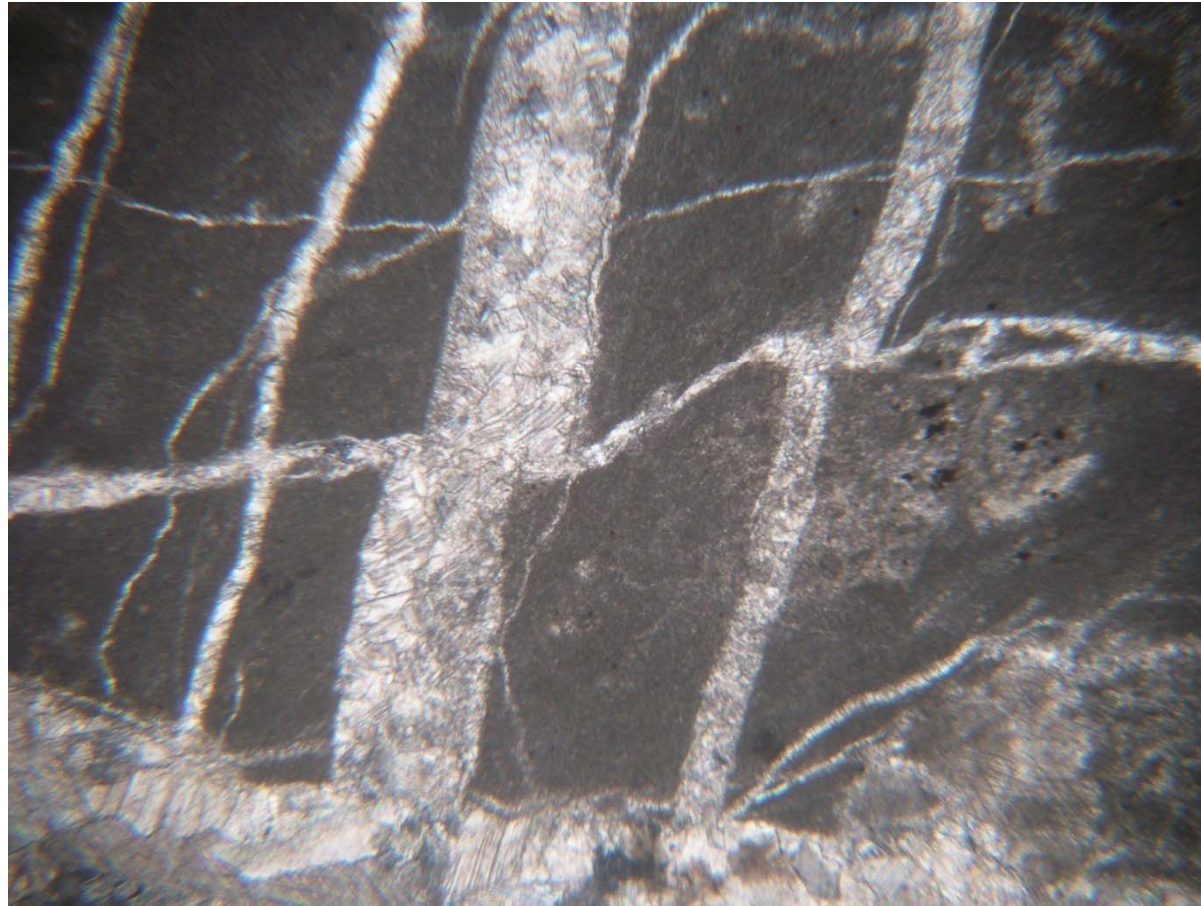
Micro-offset of post –Triassic vein at the barge site

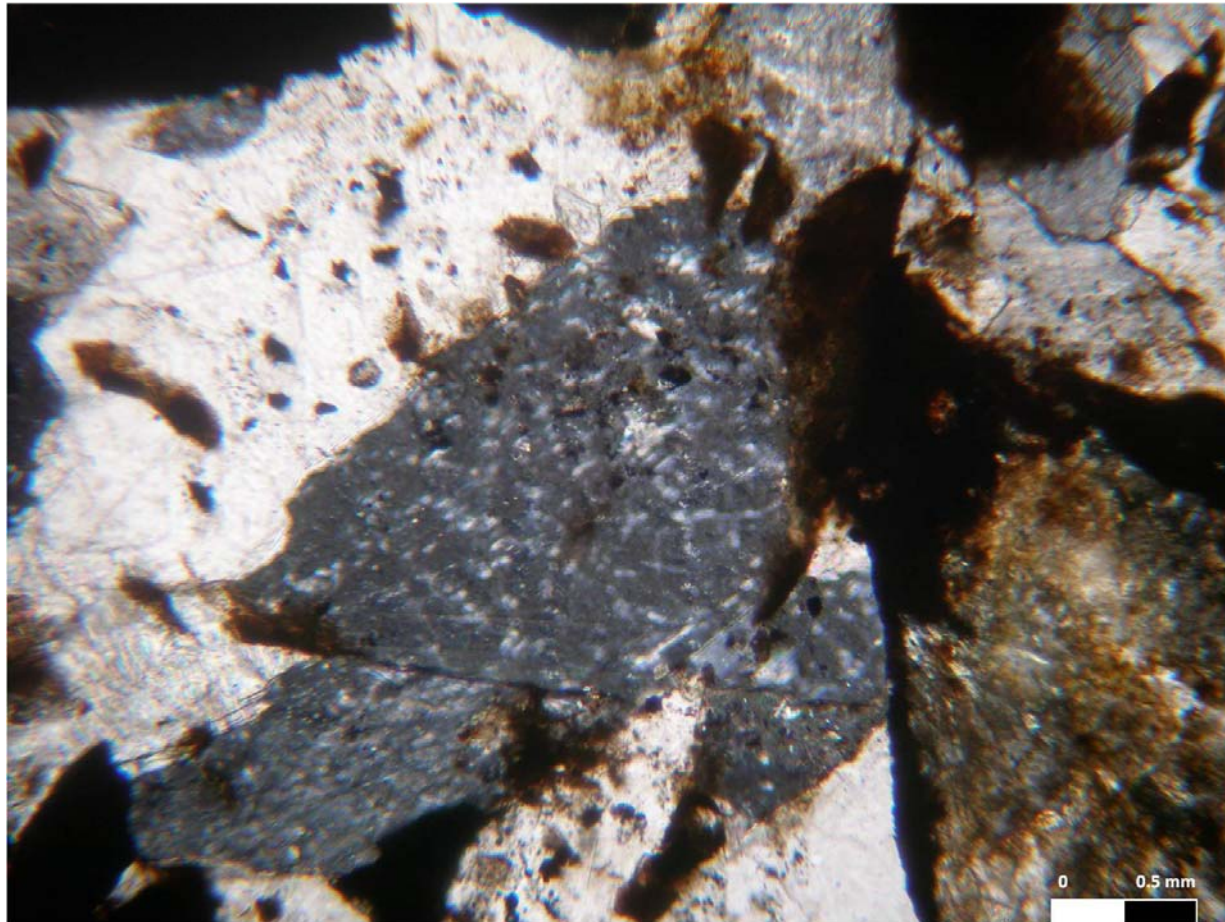
Fault breccia in calcareous sandstone at the barge site

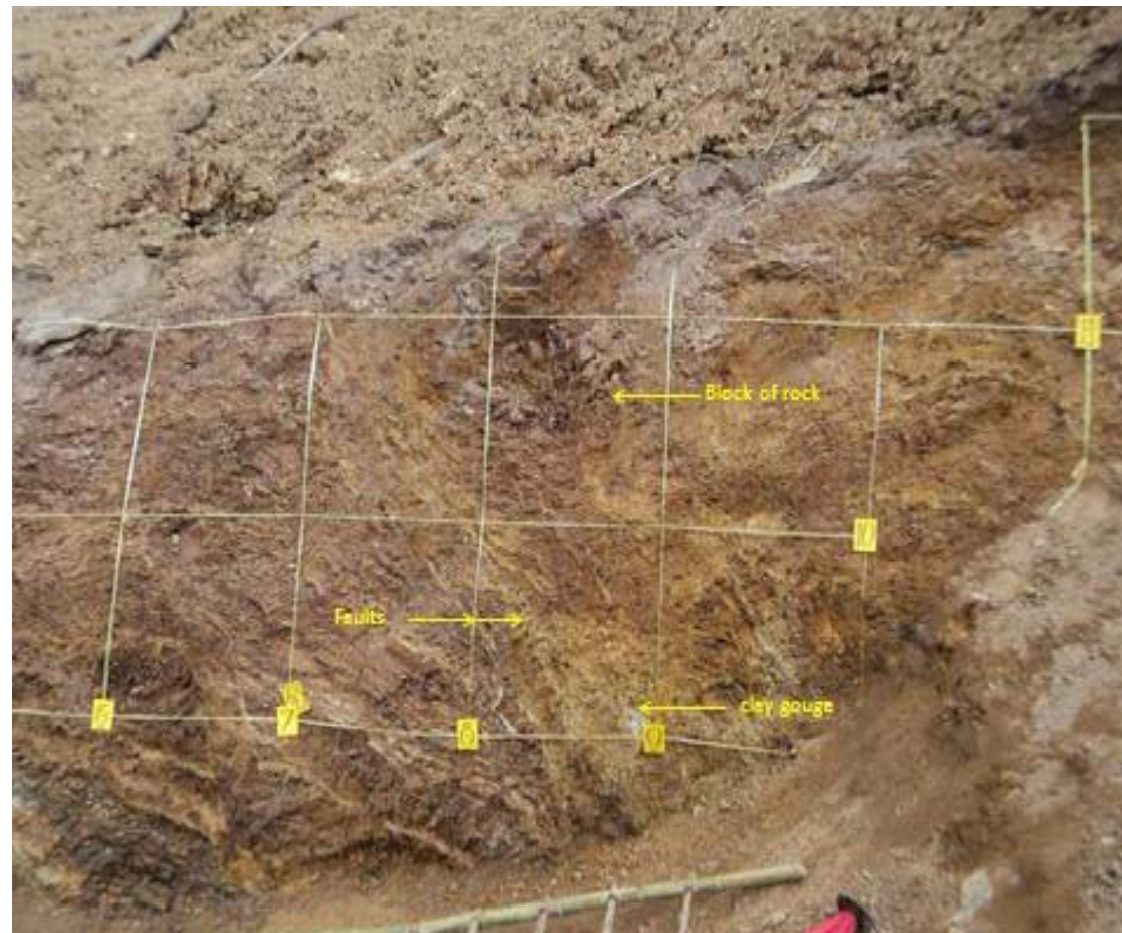
An excavation showing a fault observed in the southern wall of the Xayaburi barge site (before dam-site construction).

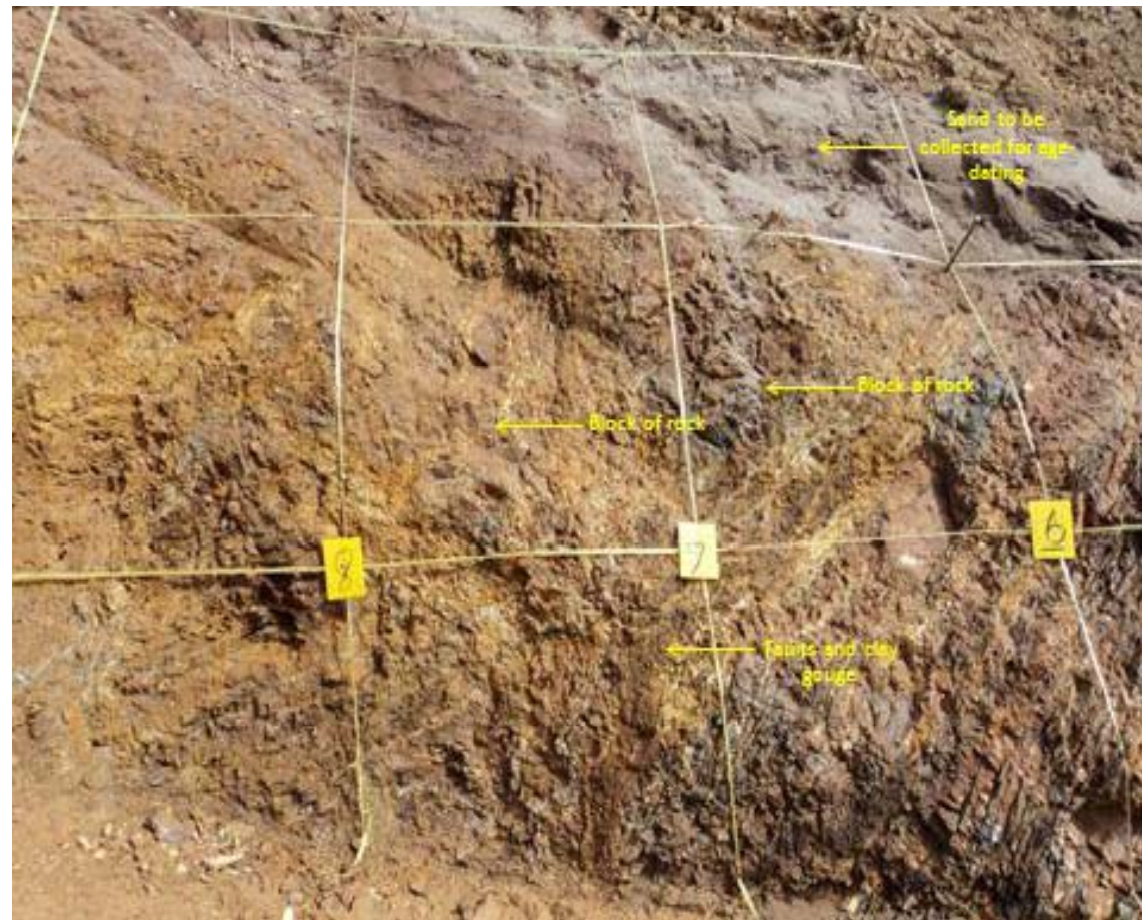
An excavation showing a fault (near no. 7 grid line) observed in the northern wall of the Xayaburi barge side (before dam-site construction)

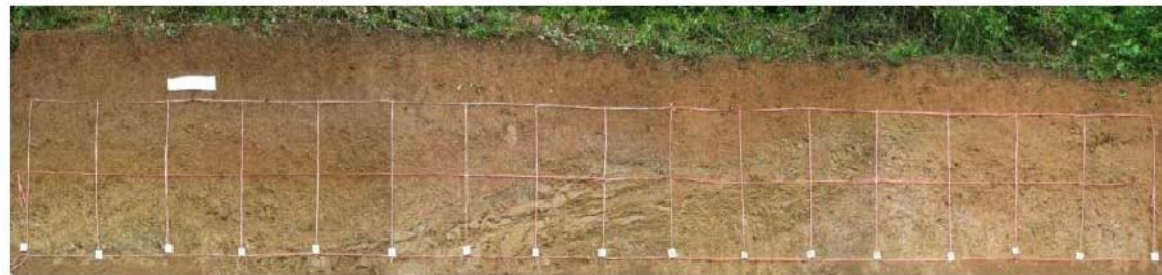
Log of trench no.T16, Ban , Xayaburi district.

- A Silty clay, yellowish brown to brown, medium to high plasticity.
 - C Gravels, sub-angular, 0.5-5 cm size, poorly sorted, composed of mostly sandstone.
 - B Laterite, reddish brown, about 1 cm size.
 - A Sandstone and siltstone, yellowish brown to whitish gray, moderately to completely weathered.
- NS 3-1 Sampling point
