Erosion and Deposition by the 2004 Indian Ocean Tsunami in Phuket and Phang-nga Provinces, Thailand

CHOOWONG, M.; MURAKOSHI, N.; HISADA, K.; CHARUSIRI, P.; DAORERK, V.; CHAROENTITIRAT, T.; CHUTAKOSITKANON, V.; JANKAEW, K., and KANJANAPAYONT, P., 2007. Erosion and deposition by the 2004 Indian Ocean tsunami in Phuket and Phang-nga provinces, Thailand. *Journal of Coastal Research*, 23(5), 1270–1276. West Palm Beach (Florida), ISSN 0749-0208.

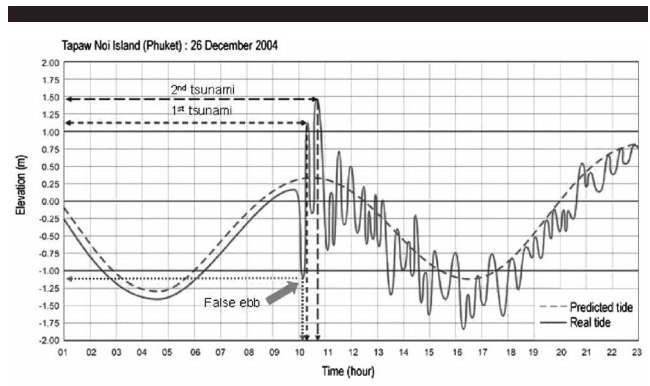
Figure 2. (A) Tapaw Noi Island (Phuket) tide gauge record showing the passage of tsunamis generated by the December 26, 2004, Sumatra earthquake. Three main waves arrived between 1020 and 1042; the second wave at 1029 was the most destructive (modified from Royal Thai Navy [2005]). (B) Tsunami heights from the Andaman coast of Thailand (Matsutomi *et al.*, 2005).

Island, eastern Phuket, is about 1.00 m from the present mean sea level (ROYAL THAI NAVY, 2005). According to this tide gauge (Figure 2A), three main waves struck eastern Phuket between 1020 and 1042. The waves were preceded by a drawdown or withdrawal that began at 1010 and lasted for 10 minutes. The second wave, the most destructive one, arrived at the gauging station at 1029 and was followed by a third tsunami at 1042. Eyewitnesses and video records confirmed that the second wave was strongest, with maximum inundation heights estimated of up to 6.00 m above ground surface and clearly recognized from water marks in the west of Phuket Island. However, tsunami flood level and maximum run-up were different from place to place (Figure 2B).

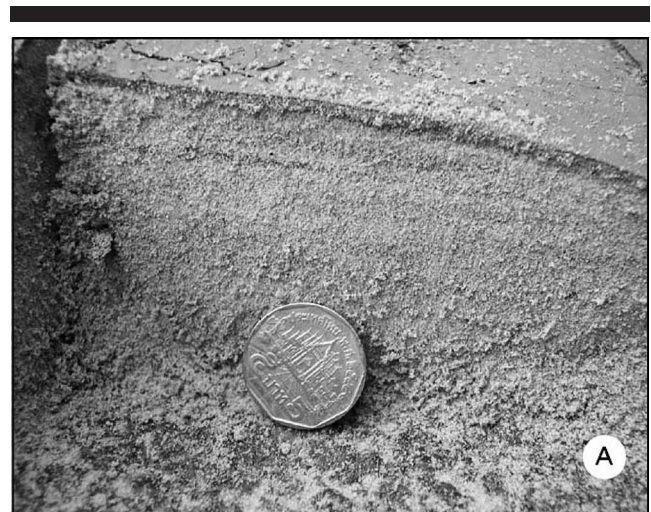
Figure 7. Tsunami sediments at Kamala beach, Phuket province, developed on gravelled road surface with average thickness of 10 cm with an upward fining of fine- to medium-grained sand and coated by a thin muddy layer on top (A) and mud cracks photographed a week after the tsunami struck (B). For color version of this figure, see page 1208.

province (Figure 6). They also indicate that tsunami upflow deposited sediment twice in this area. However, a very thin mud layer 2–3 mm in thickness coating the tsunami sand sediments was also recognized throughout, and it cracked a week after the tsunami (Figure 7). Signs of a depositional layer indicative of short-term stagnant seawater or slowly draining seawater to the shore is also likely.

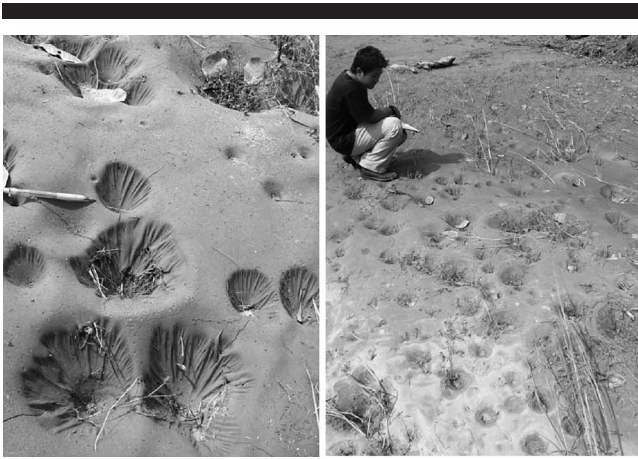
Figure 8. Erosional depressions (instant circular holes) indicating turbulence and rotation of tsunami upflow developed on pretsunami aeolian dune sediment from Ban Nam Khem, Phang-nga province. The vertical circular hole contains a thin layer of mud, 2–3 mm thick, on fine- to medium-grained tsunami sediments (5-cm thick) with a dimension varying from 2 to 15 cm wide with some granules at its bottom. For color version of this figure, see page 1208.

The evidence of vortices responsible for pretsunami surface sculpturing, especially instant circular holes that eroded into dunes, were found from Ban Nam Khem, Phang-nga province (Figure 8). Circular holes induced by tsunami here displayed as groove holes with small granules inside, and in its waning

phases, the tsunami coated the holes with a thin 2–3 mm layer of mud. On some of the dunes, the tsunami scoured circular holes 10–30 cm in diameter that extended as far as 300 m inland. Such circular holes could be indicative of rapid turbulence and rotation of tsunami upflow. A thin layer of mud then coated the holes from slowly draining stagnant water. This unique circular hole pattern was found only on the surface of pretsunami dune sediments.
